# Manhole Inspection Summary

Manhole # S2100\_002MH

Insp Date: **7/9/07 12:48 PM**

**Location** Address: **2331 FULTON**

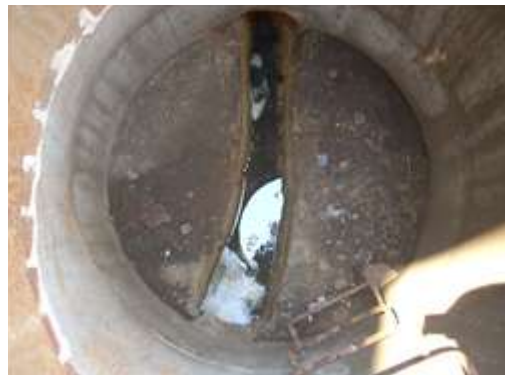
Top View

debris on channel and bench

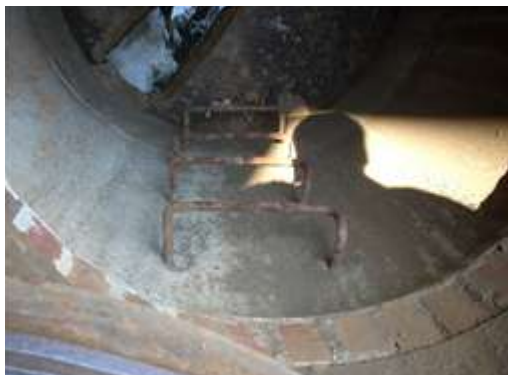
Defect 1

**Steps** Count: **4** Missing: **0** ☒ **Corroded**

corroded steps

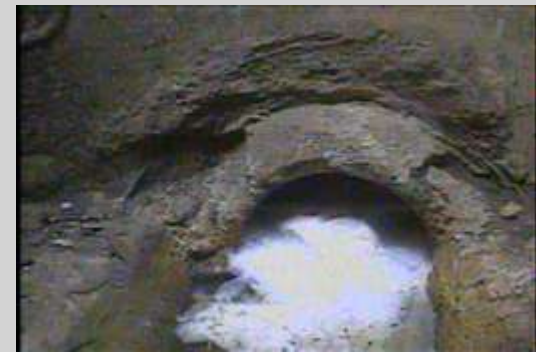
**8 in. Circular Gravity Sewer**  
**Pipe In @ 7 O'Clock**

Pipe Height: **8.4** (in.) Rod and Bar (Angled)  
Pipe Material: **Clay** ☐ Pipe Lined  
Invert Depth: **6.31** (ft.) Flow Characteristics: **Slow**  
Deposits: ☒ None ☐ Mud ☐ Sludge ☐ **Debris** ☐ Grease  
Silt Depth: (in.) Deposits Extent:  
Infiltration: **None** Pipe Seal Cond: **Sound**

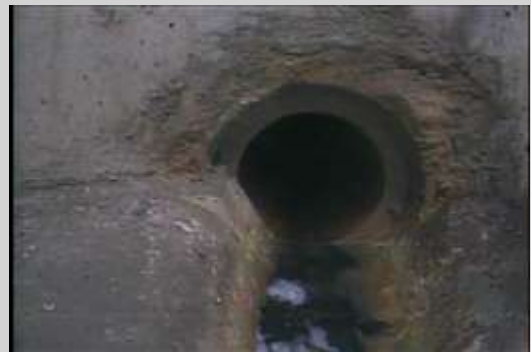
**12 O'Clock Outflow**  
**Pipe Out @ 12 O'Clock**

Pipe Height: **6** (in.) Rod and Bar (Angled)  
Pipe Material: **Clay** ☐ Pipe Lined  
Invert Depth: **6.27** (ft.) Flow Characteristics: **Slow**  
Deposits: ☐ None ☐ Mud ☐ Sludge ☒ **Debris** ☐ Grease  
Silt Depth: **4** (in.) Deposits Extent: **Medium**  
Infiltration: **None** Pipe Seal Cond: **Sound**
